Trained Eye Home Inspections, LLC

*** Residential Inspection Report ***

October 21, 2015

Ottsville, PA 18942

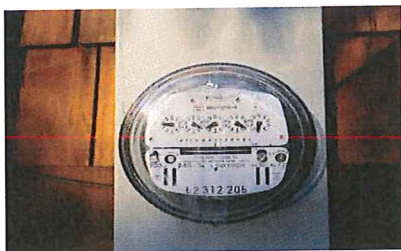
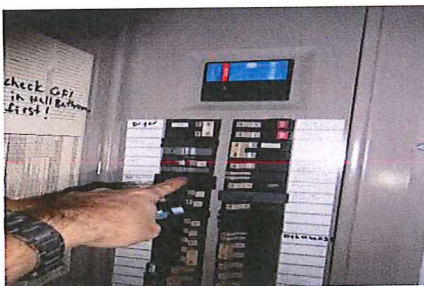
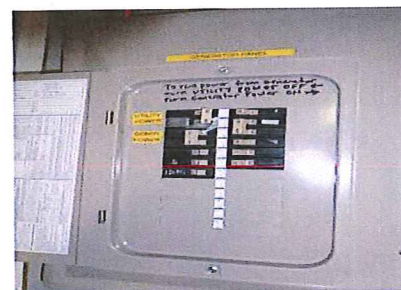
Electrical Observations

The main electrical panel was missing several knockouts. This is a safety hazard and should be corrected by a licensed electrician.

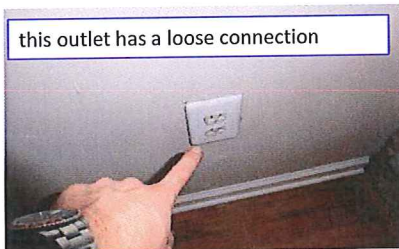
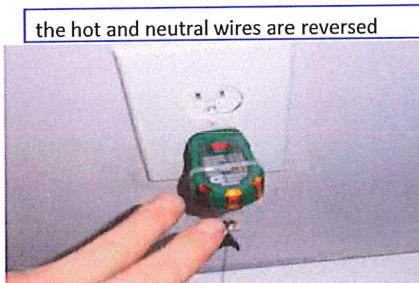
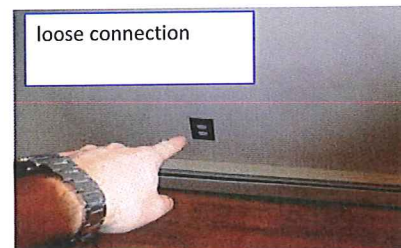
Electrical: Interior / Bedroom Areas

Observation: Various outlets in the bedrooms and common areas were defective. Recommend a licensed electrician evaluate the entire electrical system and make proper corrections. There are exposed wires in the drop ceiling in the basement near the water softener equipment, this is a safety hazard. I Recommend that all smoke and carbon monoxide detectors be hard wired to the building's electrical system and be equipped with a rechargeable battery backup. Smoke detectors should be located in all bedrooms, basement and in any utility room containing a furnace or boiler. CO detectors shall be centrally located outside of each separate sleeping area in the immediate vicinity of the bedrooms, and each detector shall be located on the wall, ceiling or other location as specified in the installation instructions that accompany the unit. At the time of inspection there were no visible CO detectors in the house. Recommend replacing all smoke detectors immediately upon settlement.

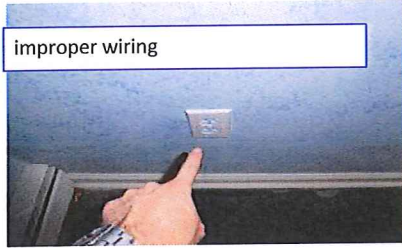
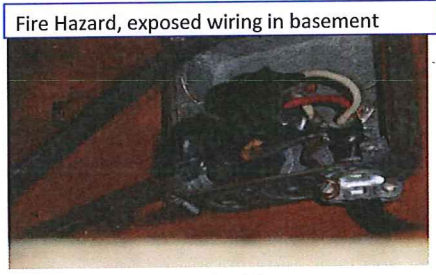
fire hazard. Exposed wiring

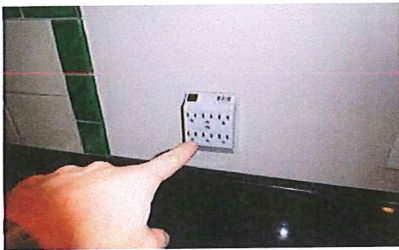
Electrical: Kitchen / Bathroom / Exterior Areas

Observation: the multi plug outlet in the kitchen near the stove is not functioning as intended. At the time of inspection 3 of the 6 outlets were functioning properly. Recommend replacing the unit.

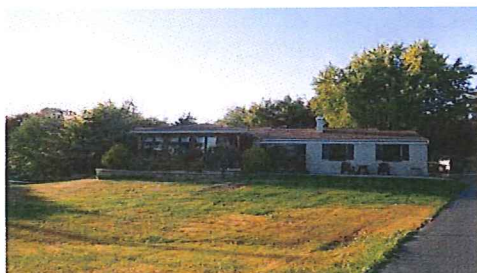
Further Comments: There is a pond in the front yard. This pond is a safety/ drowning hazard for small children and pets. Recommend installing a fence around pond for safety and to keep all children and pets away from pond. Recommend treating the pond to prevent mosquito infestation.

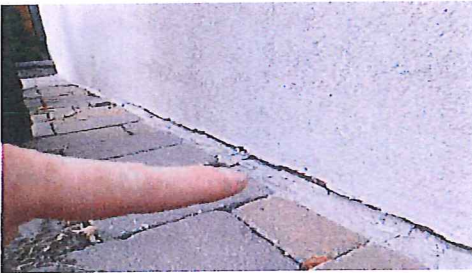
Further Comments: There is a settlement crack in the front of the house where the paver patio meets the house. When the patio settled it created a separation from the home's stucco coating. I recommend a licensed contractor apply sealant to the crack to prevent further damage from water infiltration.

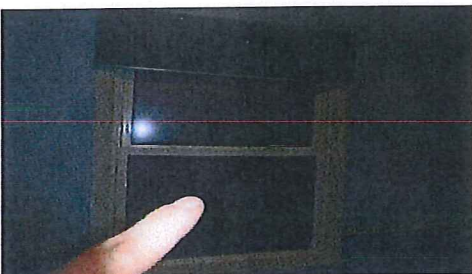
Window(s)

Further Comments: the window in the bedroom is fogged due to a broken seal. Recommend replacement.

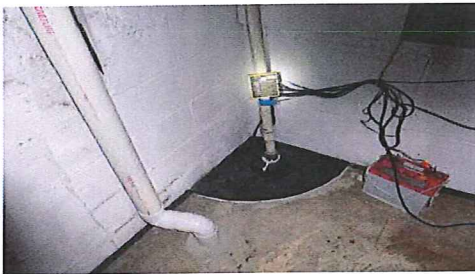
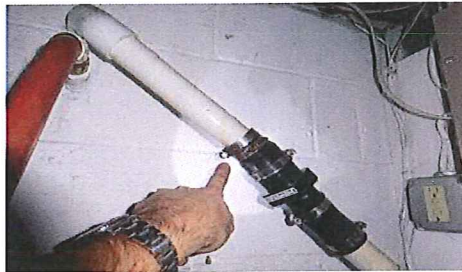
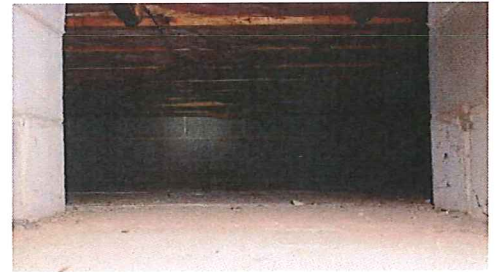
Basement - Drainage - Sumps and Pumps

Further Comments: At the time of inspection there was a drip of water on the check valve. Recommend monitoring this as the pump operates to be sure it isn't leaking. At the time of inspection there was a battery back up system installed on the sump pump. Recommend monitoring the battery and the system to be sure its operation when needed. The sump pit was sealed from the radon mitigation system. The inspector could not operate the pump to test at the time of inspection. There is a second sum pump installed near the main sum pump. This pump is directly plumbed to the exterior via a flexible hose.

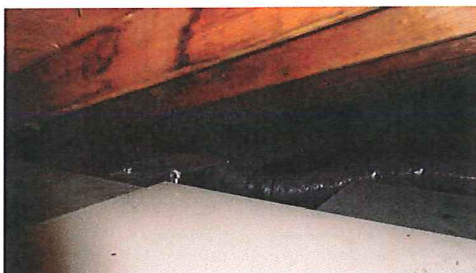
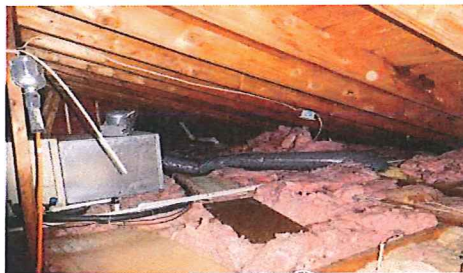
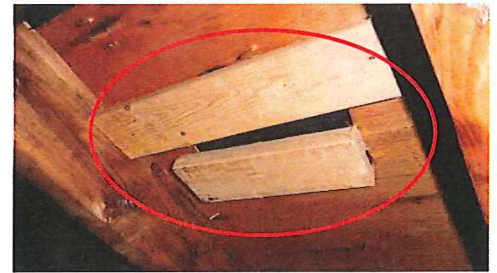
Further Comments: There is a patch on the roof in the attic (circled in red below). This is not a proper patch to support the weight of a person from falling through and causing further damage. I recommend repair by a licensed roofing contractor.

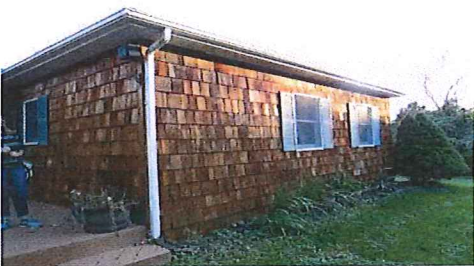
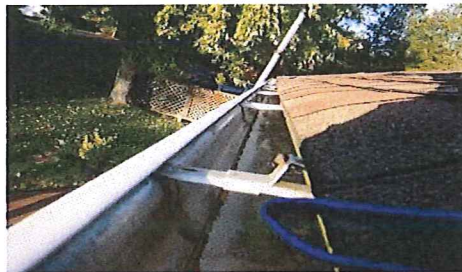
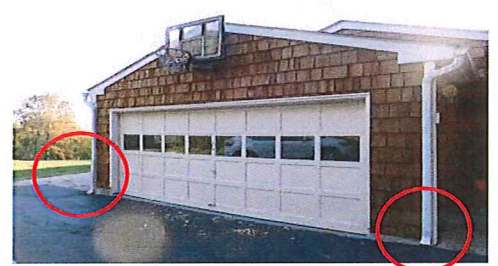
Further Comments: Recommend extending the downspouts to discharge further away from the house. At the time of inspection the two downspouts terminated at the base of the house onto the driveway. A crack in the driveway where it meets the house under the front downspouts should be sealed to not allow water from downspout to leak into the hole and cause costly damage to the driveway. Recommend having a qualified contractor repair the crack as needed.

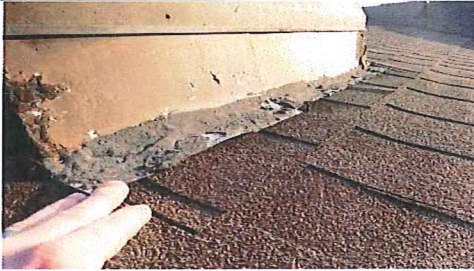
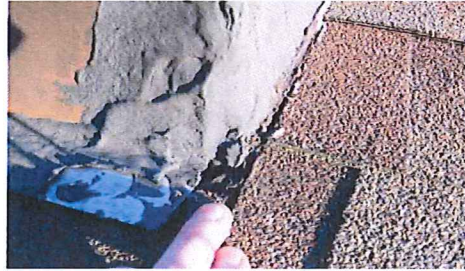
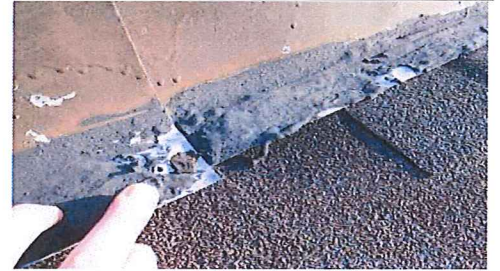
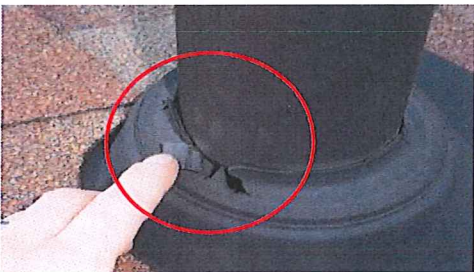
Flashing

Further Comments: Recommend further inspection from qualified professional. Workmanship is poor on the sealant on the sky lights. The boot seal on the vent pipe is damaged and in need of repair or replacement.

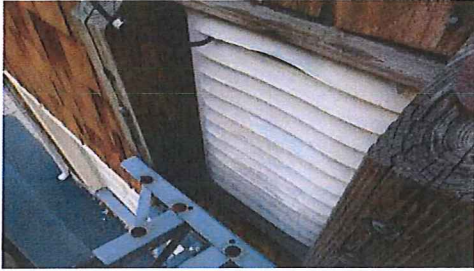
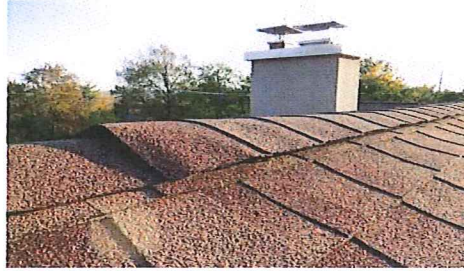
Attic Vents

Further Comments: There are gable vents as well as a ridge vent. This type of multiple venting can counter act each other and not allow each system to operate as intended. Recommend monitoring attic conditions/ temperature. If excessive heat is noticed I recommend having a qualified roofer evaluate the system and correct as needed.

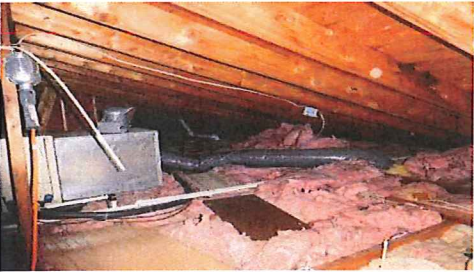
Insulation

Further Comments: Recommend correction of the attic insulation. The insulation should cover the ceiling joist to prevent conduction of cold and hot air towards the interior ceiling.

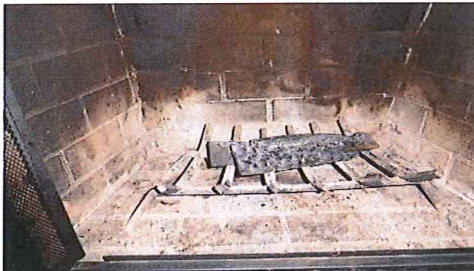
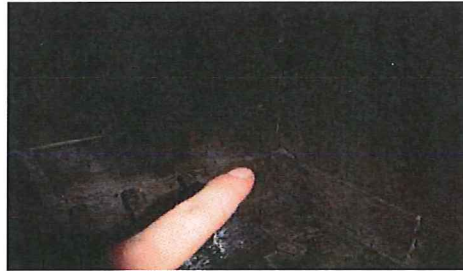
Further Comments: Some cracks were visible at the time of inspection. Recommend a full evaluation of the entire system including the chimney before close of escrow and absolutely before use. There was evidence of creosote buildup at the time of inspection. The National Fire Protection Association (www.nfpa.org) advises that each chimney receive a Level II inspection each time a residence is sold. Inspection levels are explained at www.csia.org It is also advised that this inspection be conducted by a chimney sweep certified by the Chimney Safety Institute of America (www.csia.org).

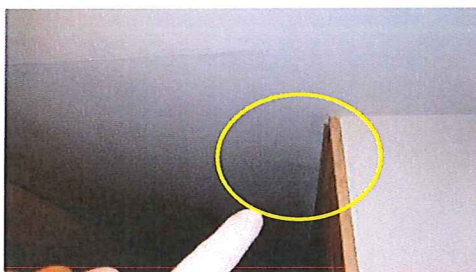
Further Comments: Evidence of correction from prior damage. At the time of inspection the area was dry and there was no evidence of a leak. There is evidence of a prior repair.

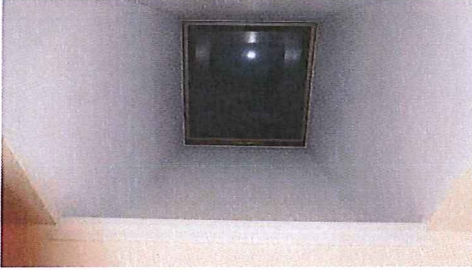
Window(s)

Further Comments: One of the sky lights appeared to have fogged glass. This could be caused by a broken seal. Recommend further evaluation before close of escrow.

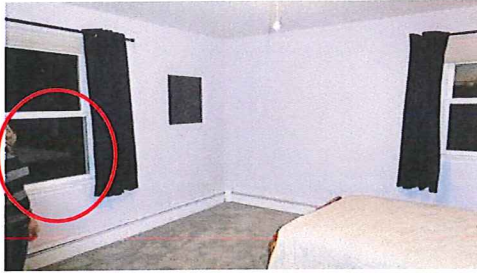
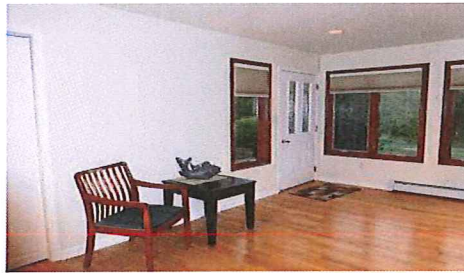
Further Comments: The window in the bedroom was fogged at the time of inspection. The seal to the glass is broken and it allowed air to get in. The fog appearance on the glass is cause by the moisture in the air staining the glass. Recommend replacing the window or get a replacement sash.

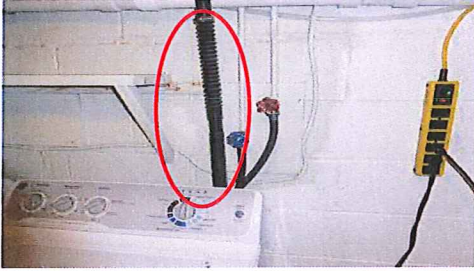
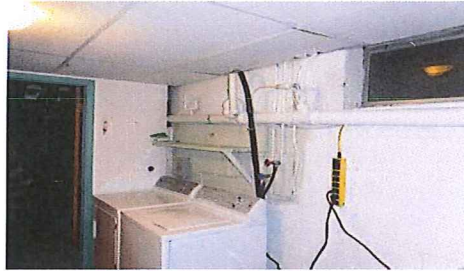
Further Comments: The flexible drain line for the washer water discharge is not properly attached to the drain. Recommend a licensed plumber evaluate and correct. This drain line could become loose and detach and cause a flood.

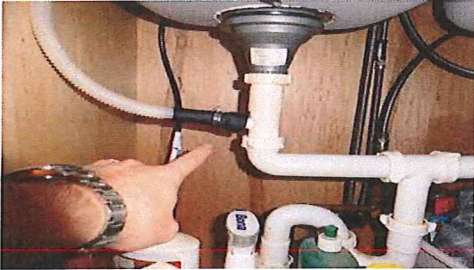
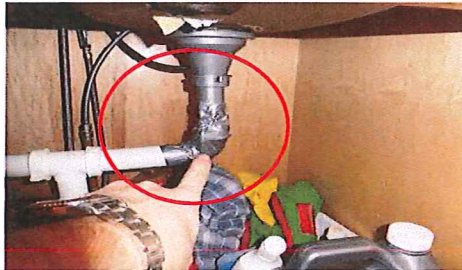
Material: Copper and ABS. At the time of inspection the was duct tape on the kitchen sink drain line. Recommend licensed plumber repair drain with proper connections.

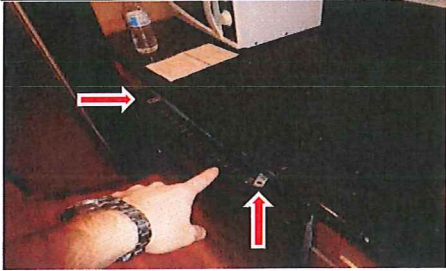
Incorrect or missing pieces. The dishwasher is not connected to the underside of sink. The dishwasher needs to be securely mounted for proper safety and operation. Recommend repair of the dishwasher by qualified contractor.

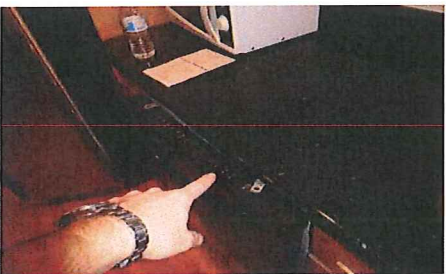
The dishwasher is not installed properly. The machine should be attached with screws to the counter above. Recommend a licensed contractor correct as needed.

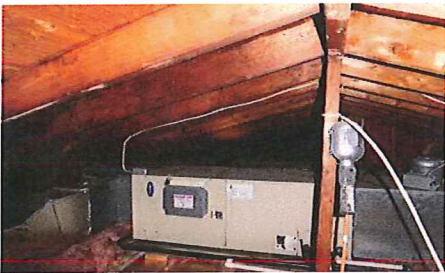
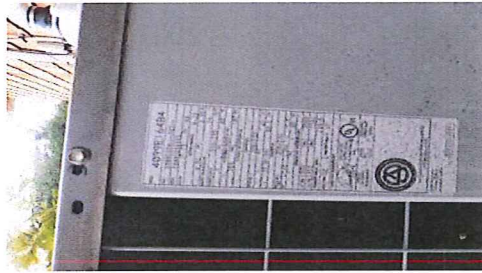
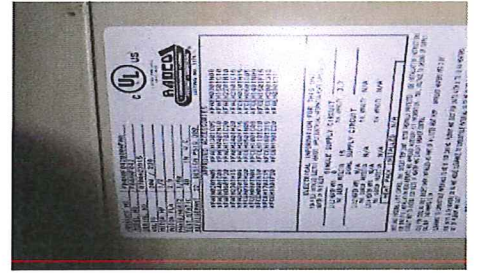
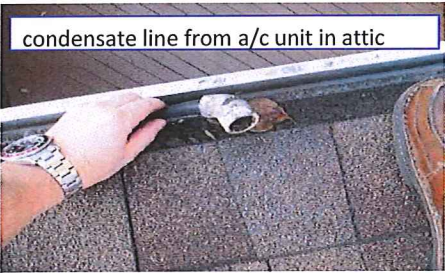
The air conditioning condenser is at the end of useful life. Recommend replacement in the near future. There is a whole house return duct located in the main hall. Recommend replacing the filter every season and having HVAC system evaluated each year and before close of escrow to ensure proper operation. I also recommend having all the ducts cleaned to ensure quality air control in the house for people with allergies to mold spores and dust. The system was not tested at the time of inspection.
