Trained Eye Home Inspections, LLC

*** Residential Inspection Report ***

October 21, 2015

Ottsville, PA 18942

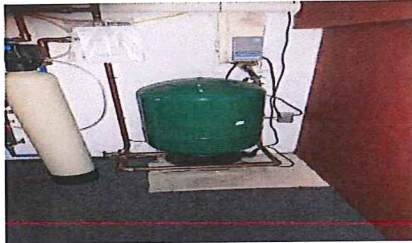
Recommend having the well, pump, and all its components inspected by a qualified well inspector before close of escrow.

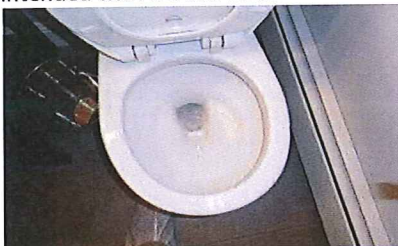
Sewage Supply System

The septic system is supplied by ABS and PVC piping. There were no leaks at the time of inspection. The drains were functioning as intended with normal flow.

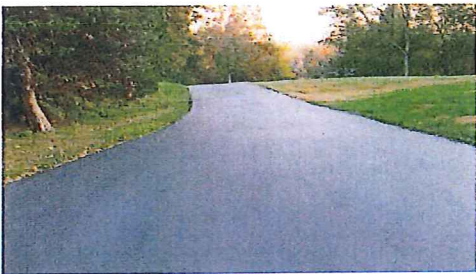
Further Comments: Recommend applying an asphalt sealant every few years. This will extend the life of your driveway.

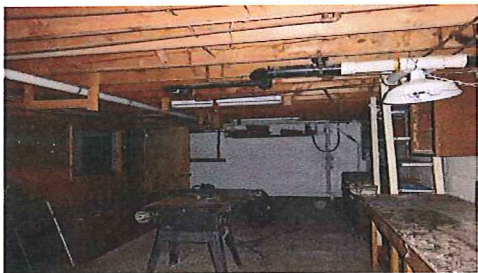
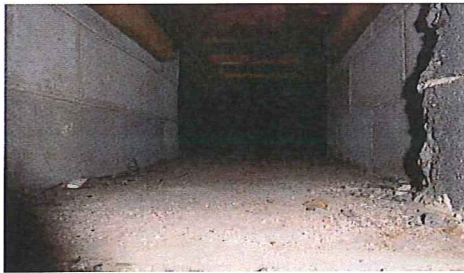
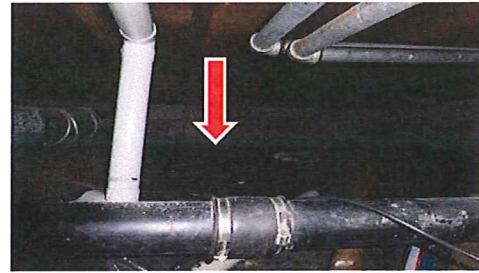
Further Comments: There is a plastic tarp in the crawl space. This is installed to prevent moisture from the floor from escaping and settling on the underside of the wood floor frame members and causing moisture damage and possibly creating conditions conducive to mold growth. Always ensure the bare ground is covered with this material to prevent described damage.

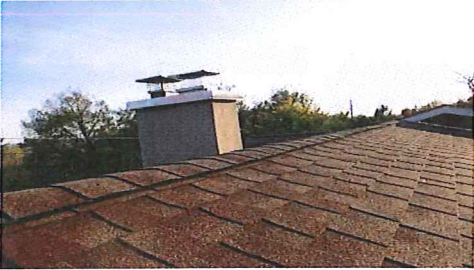
Further Comments: The two chimney flues are for the fireplace and the other is for the furnace venting.

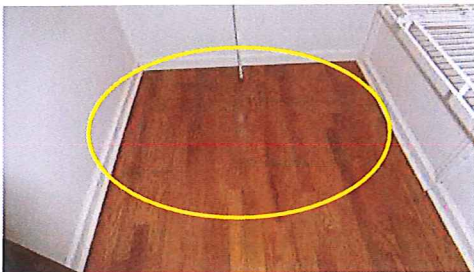
Further Comments: There is an access panel in the floor in the bedroom closet to access the crawlspace area under the house.

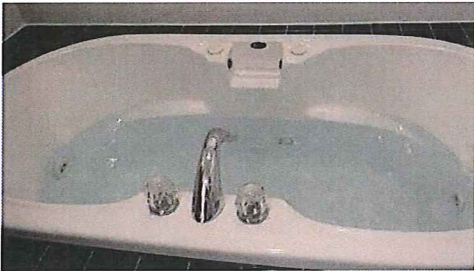
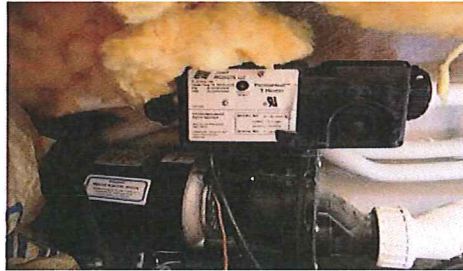
Further Comments: The master bath has a jetted tube installed. The proper amp circuits were in place for the pump and heater. The heater was not tested at the time of inspection but the jets were tested after the tub was filled. Always be sure to have all the jets fully submerged under water before operation occurs. This will ensure the water does not get ejected from the tub into the bathroom area. Always follow the Manual to the tub for proper operation and proper clearing of the water lines in the tub.
